## Frost Resistance of Cover and Liner Materials for Landfills and Hazardous Waste Sites

Edwin J. Chamberlain, Allan E. Erickson, and Craig H. Benson

December 1997

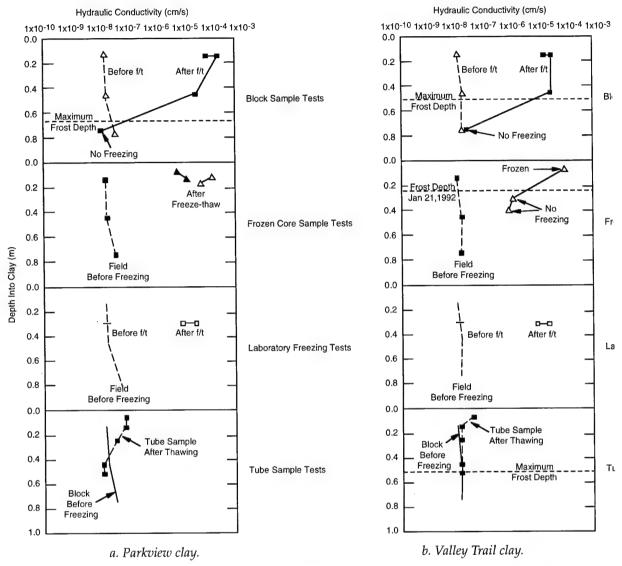
Figure 8. Summary of hydraulic conductivity test results.

Comparisons of our laboratory and field tests on the two natural clays (Parkview clay and Valley Trail clay) show that freeze-thaw cycles caused an increase in hydraulic conductivity of three to four orders of magnitude (Table 2 and Fig. 8). The increase in hydraulic conductivity for the Parkview clay was from about  $3 \times 10^{-8}$  cm/s to greater than  $1 \times 10^{-4}$  cm/s. For the Valley Trail clay, the increase was from about  $2 \times 10^{-8}$  cm/s to about  $8 \times 10^{-5}$  cm/s.

This increase in hydraulic conductivity is attributed to the formation of cracks from ice lenses and shrinkage. Thin sections (Fig. 9) and half sections (Fig. 10) cut of these materials show the ice-filled cracks between aggregates of soil. A scanning electronic microscope (SEM) photograph (Fig. 11) shows further detail of a crack

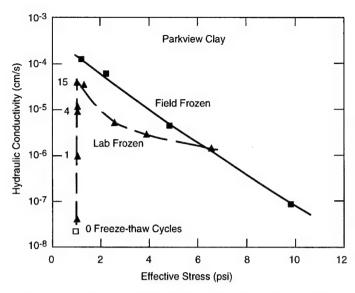
Figure 13. Impact of effective stress on the hydraulic conductivity of Parkview clay after freezing and thawing.

To show this stress effect, hydraulic conductivity tests were also conducted on test specimens at higher stress levels than normally used in the back-pressure permeameter—i.e., at stress levels up to 10 lb/in.² (69 kPa) in comparison with the 1 lb/in.² (6.9 kPa) effective stress level normally used in our tests. Figure 13 shows that increasing stress decreases the hydraulic conductivity of the Parkview clay and that about 12 lb/in.² (83 kPa) of stress is needed to decrease the hydraulic conductivity to its value before freezing.

The increasing stress test results also show where, in a landfill or hazardous waste site, freezing and thawing has its greatest impact. In covers, even with several feet of frost protection, the maximum effective stress will not generally exceed 3 or 4 lb/in.<sup>2</sup> (21 or 28 kPa), whereas the stress level in a clay liner can easily exceed 12 lb/in.<sup>2</sup> (83 kPa). The stress level in a cover will, thus, in most cases not be great enough to close the cracks and reduce the hydraulic conductivity to an acceptable value,

whereas in a liner, there can easily be sufficient overburden stress to close the cracks and reduce the hydraulic conductivity to an acceptable value. About 25 ft (7.6 m) of overlying soil and waste material would be required to close the cracks in a liner constructed with the Parkview and Valley Trail soils. This is an overburden readily achieved in most landfills, except at the margins.
